## Excerpt - Pre-Design Report

Building Addition | Feasibility Study

## **McKee Public School**

35 Church Ave., North York, ON

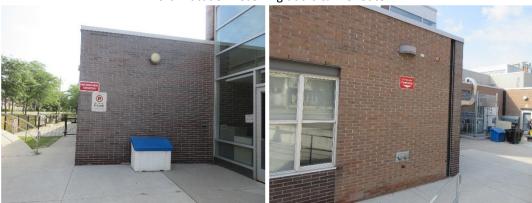
North Façade- Fire Department Connection

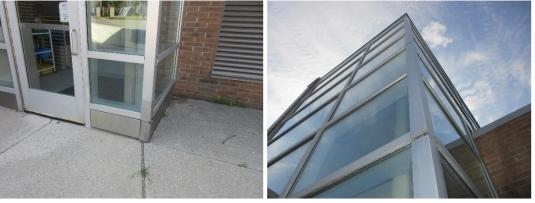
Alum. Curtain Walls & Doors- Minor damages & gaps between pressure caps

- Aluminum Curtain Walls are generally in a good condition although Etude did note a number of locations where aluminum pressure caps and trims have become separated with large gaps. These systems should be reviewed for potential maintenance and sealant.

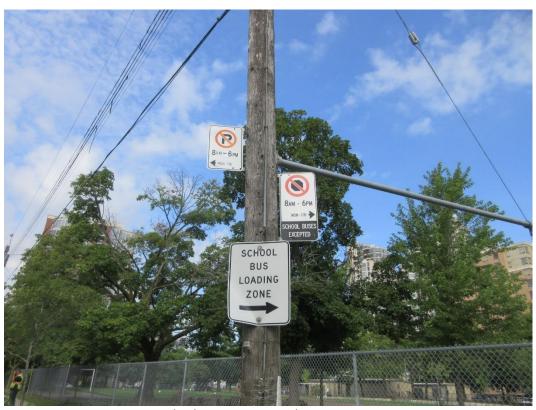
Bus loading zone signage along McKee Ave.

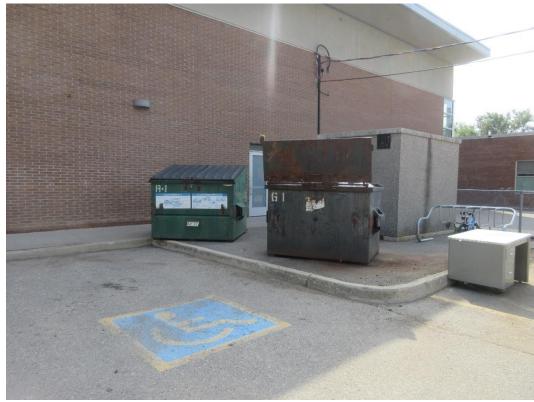
Automatic door operators were noted at exit No.1, 5, & 8. Two Barrier free parking spaces are located in the West parking lot near the school's main entrance utilize curb cuts and low slope pathways to establish a barrier free path of travel to the main school doors (entrance No.1). The garbage bins being located directly next to barrier free parking space no.2 does not appear to hinder the space.

B.F. Parking spaces

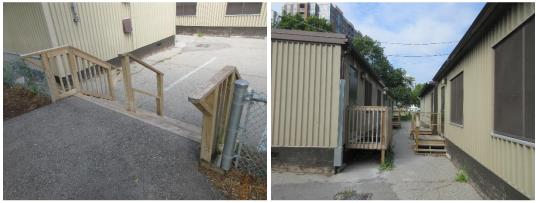
Portables configured in the West parking lot are not barrier free accessible. A wood staircase is the main entry and access point into the portable area and the portables themselves are not accessible.

Portable Classrooms not accessible

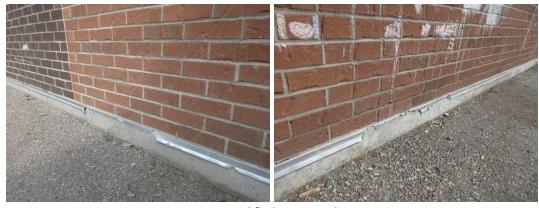
Damaged flashing at grade

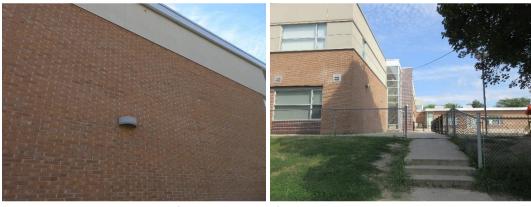
- Stucco Finishes are limited to areas high above grade under soffits. Etude was unable to
  closely review these finishes but from grade they appear to be in good overall condition.
  No visible damages or deterioration were noted.

Stucco finishes at second floor in good condition

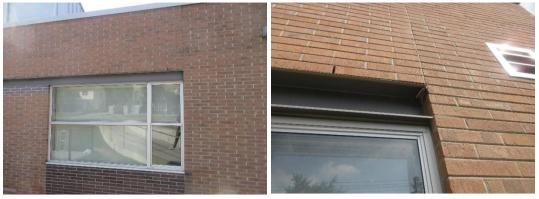
- Aluminum Punch Windows are in good condition throughout the building. Caulking joints and sealant as well as aluminum sills and capping are all noted to be in good condition.

Aluminum windows in good condition

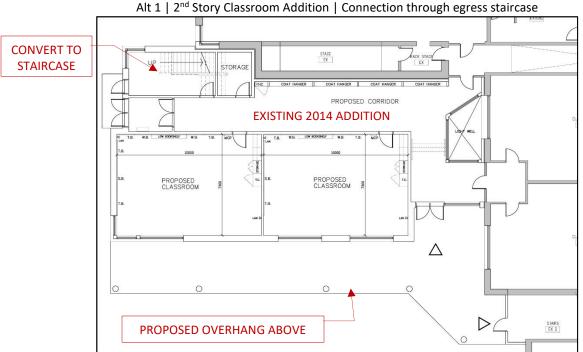
A second story 3 classroom addition will be constructed above the existing Classrooms 99 and 100. The cantilever of the Classrooms may require structural columns at grade. The proposed Classrooms are designed as per TDSB design guidelines and provincial bench-mark standards. A new corridor extends from the proposed classrooms to the existing 2<sup>nd</sup> floor corridor through an existing egress staircase. The expected modifications to the existing building are as follows:

Alt 1 | Existing Ground Floor | + Columns and Overhang

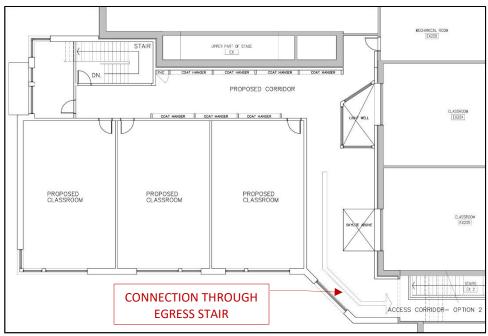
- 1 existing ESL room will be converted into an egress staircase
- 1 existing egress staircase will be modified to allow access to the addition and maintain exiting strategy
- Minimal impact to the existing outdoor play areas

Alt 1 | 2<sup>nd</sup> floor | Connection through Egress Stair

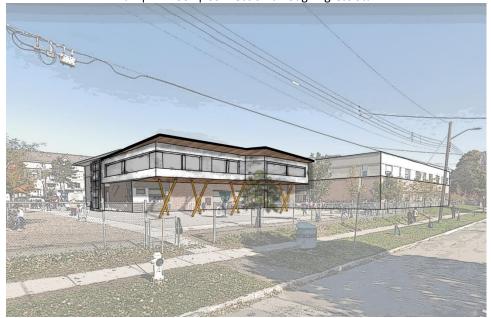
Alt 1 | Perspective sketch from McKee Ave.

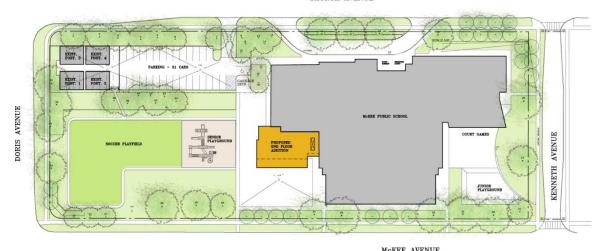
Alt 2 | 2<sup>nd</sup> Story Classroom Addition- Connection through Mechanical Room

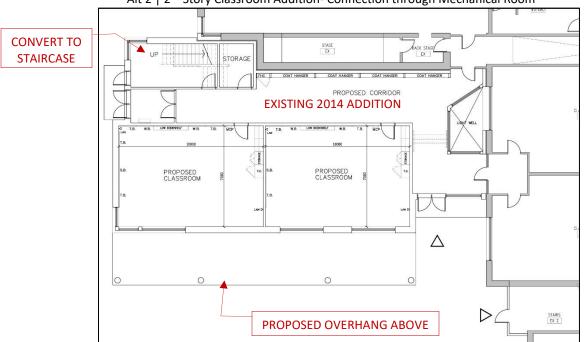
Alt 2 | Existing Ground Floor | + Columns & Overhang

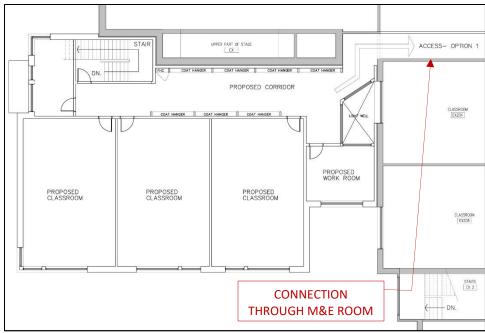
Mechanical Room adjacent to Classroom 204 will be re-worked to allow for a corridor passthrough to be carved out of the space and provide access to and from the proposed addition. The equipment housed in this mechanical room is extensive and space is already limited. Re-arranging equipment and services may be challenging. The expected modifications to the existing building are as follows:

Alt 2 | 2<sup>nd</sup> Floor | Connection through Mechanical Room

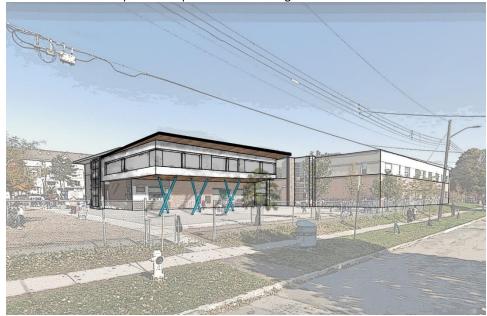
Alt 2 | Perspective sketch from McKee Ave.
